Manhole Inspection Summary

Manhole # S31UU1012MH

Location Address: **100 SAINT ALBANS WAY**

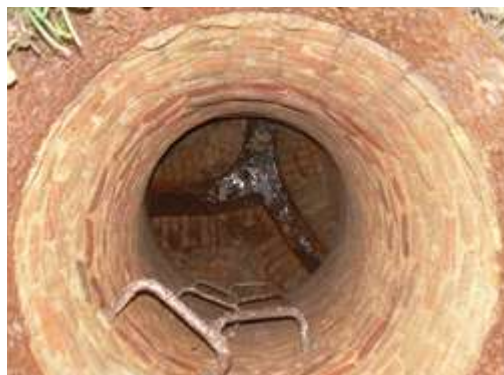
Top View

Count: **6** Missing: **0** ☒ **Corroded**

Corroded steps.

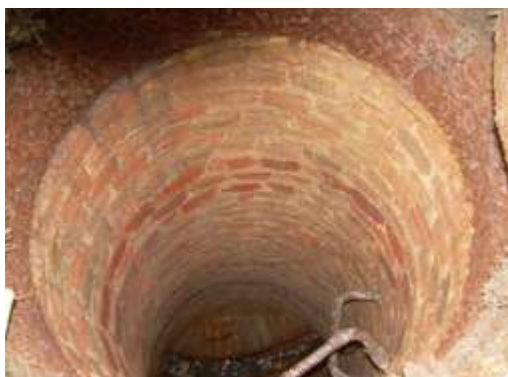
Defect

Condition: ☐ Sound ☐ Cracked ☐ Root Intrusion ☐ Loose Brick ☒ **Deteriorated**

Infiltration: ☐ None ☒ **Joint** ☐ Cracks ☒ **Mortar** ☐ Roots ☐ Wall

Infiltration: ☐ None ☐ Joint ☐ Cracks ☒ **Mortar** ☐ Roots ☒ **Wall**

Adjustment deterioration and infiltration.
Corbel and Barrel infiltration - other side.

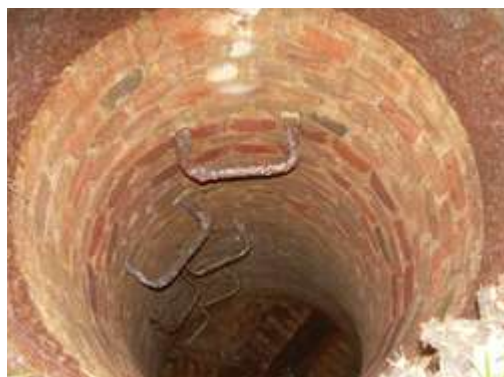
Defect

Adjustment deterioration and infiltration.
Corbel and Barrel infiltration - other side.

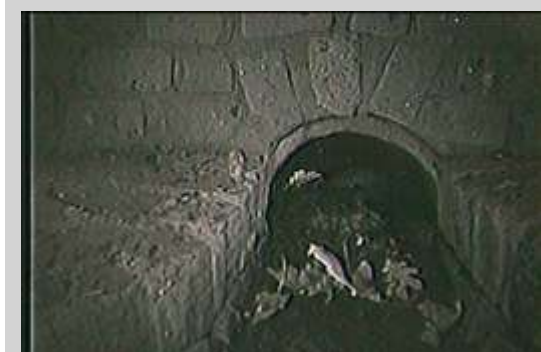
Pipe Out @ 12 O'Clock

Deposits: ☐ None ☒ **Mud** ☐ Sludge ☒ **Debris** ☐ Grease

Infiltration: **Evidence** Pipe Seal Cond: **Unknown**

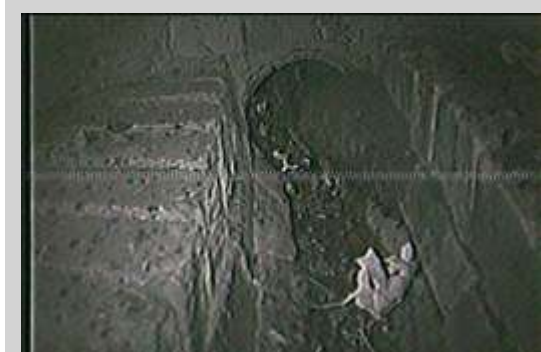
Pipe In @ 5 O'Clock

Condition: ☐ Sound ☐ Cracked ☒ **Root Intrusion** ☒ **Deteriorated** ☐ Leaks ☐ Debris

Channel deterioration and root intrusion.

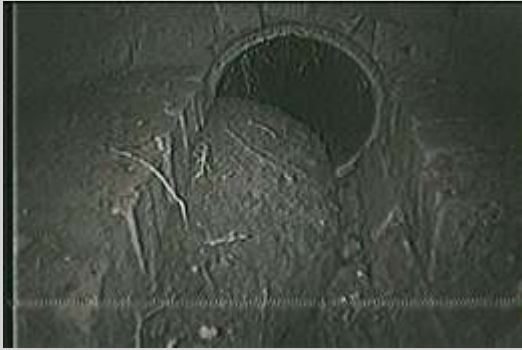
Pipe In @ 9 O'Clock

Channel deterioration and root intrusion.

Infiltration: **Evidence** Pipe Seal Cond: **Cracked**
